# Fish-Passage Field Findings

June, 2020

## Case study 02: Flexi-Baffle installation to restore fish passage in a long, complex culvert

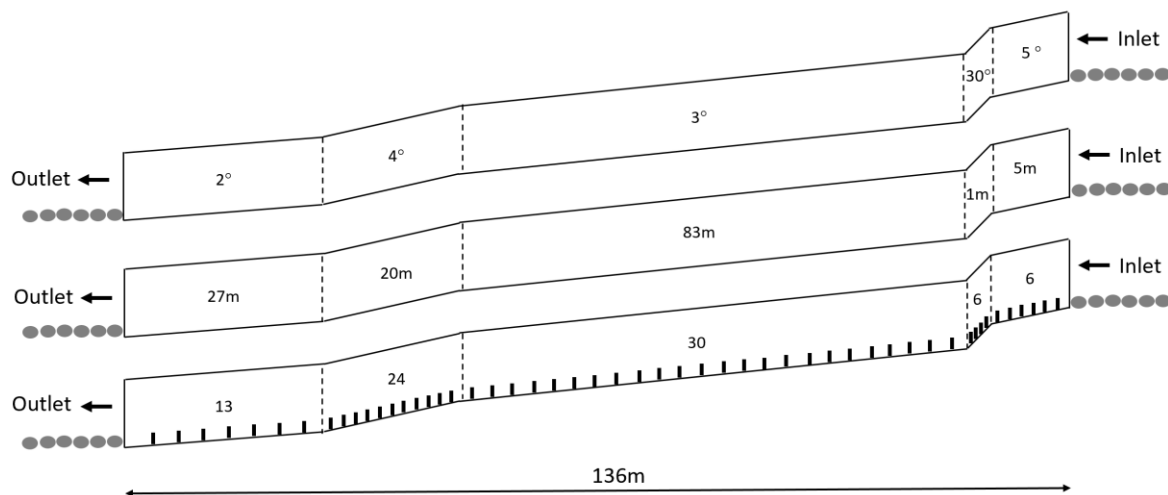
Reservoir Creek is a small, coastal stream that runs through urban Nelson. Approx. 1.5 km inland from the coast at an elevation of 31 m, the stream is piped through a complex culvert system. The culvert is 1.6 m diameter, 136 m long and has variable gradients ranging from 2° to 30° (Figure 1). The culvert is made up of different materials (concrete and metal) and changes direction numerous times. Fifteen previous fish records show that longfin and shortfin eels (*Anguilla dieffenbachii* and *A. australis*), banded kokopu (*Galaxias fasciatus*), koaro (*Galaxias brevipinnis*) and common bully (*Gobiomorphus cotidianus*) were found upstream and downstream of the culvert, while Inanga (*Galaxias maculatus*), and redfin bully (*Gobiomorphus huttoni*) were only found downstream (source NZ Freshwater Fish Database). It should be noted that there is only one record of common bully upstream of the culvert.

Figure 1. Cross section of Reservoir Creek culvert showing changes in gradient, length and number of baffles installed.

The spacing between baffles, and the number of baffles installed, was determined by the culvert gradients (i.e. more baffles were installed in shorter intervals where gradients were steeper) (Figure 1; Table 1).

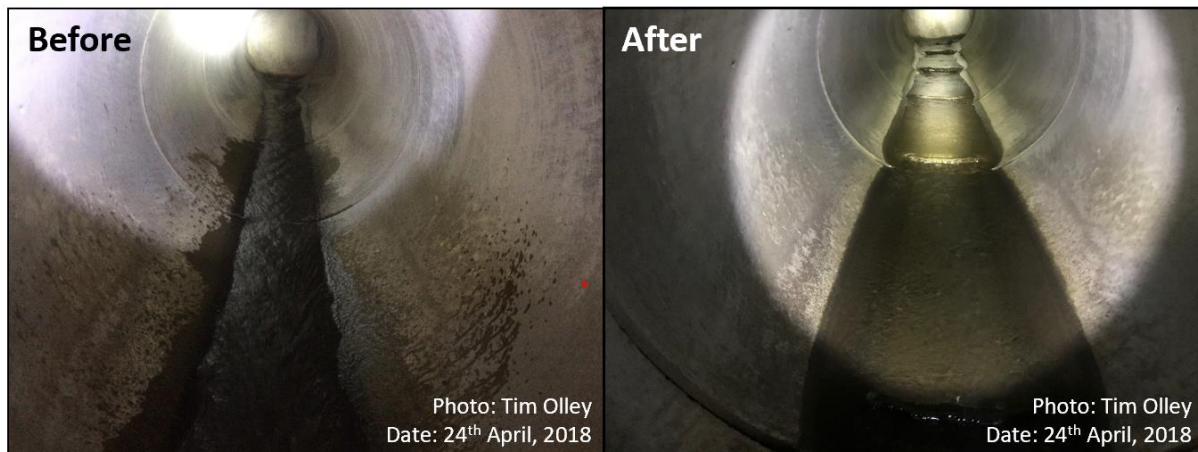
It was considered that high barrel water velocities due to the steepness of culvert gradients were impeding successful upstream passage of fish.

Figure 2. Lower section of the Reservoir Creek culvert before and after Flexi-baffle installation.

In April 2018, a total of 79 Flexi-baffles (ATS Environmental Ltd) were secured within the culvert to reduce water velocities and create resting pools within the culvert (Figure 2). Flexi-baffles are a type of flexible baffle made of a recycled polymer and were fabricated to suit the culvert. All 79 baffles were 600 mm wide and 100 mm high with 50 mm slits and 45-degree cuts at both ends to allow fish passage around the baffle (Figure 2 and 3). The baffles were attached to the concrete culvert floor with stainless-steel sleeve anchors (M6.5 x 40 mm) and stainless-steel penny washers (32 mm). In the metal section of the culvert we used stainless steel tek-screws (14G x 25 mm) with stainless-steel penny washers (32mm).

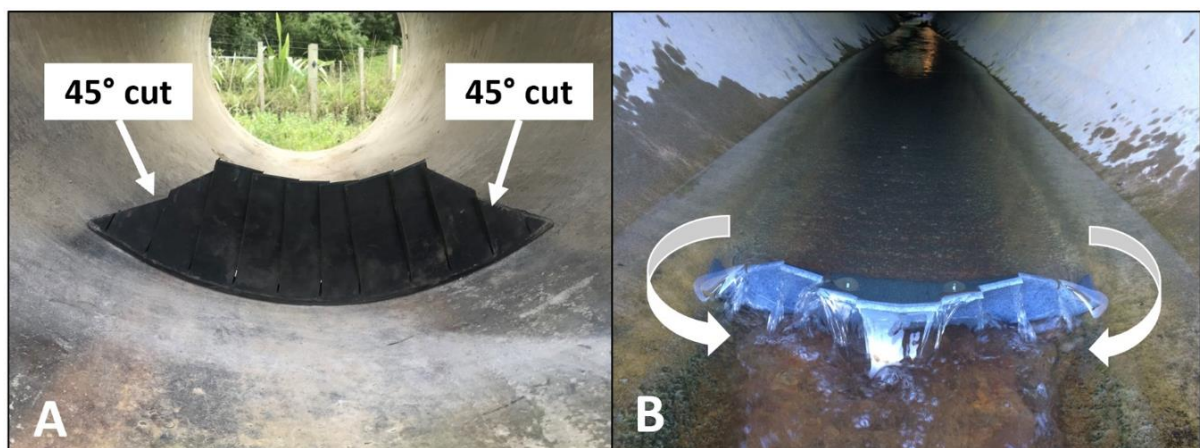
Figure 3. Each baffle is cut at 45° on either side (A) to allow water to spill around the baffle (B) enabling fish passage, even at low flows (Note: photographs are not from Reservoir Creek culvert).

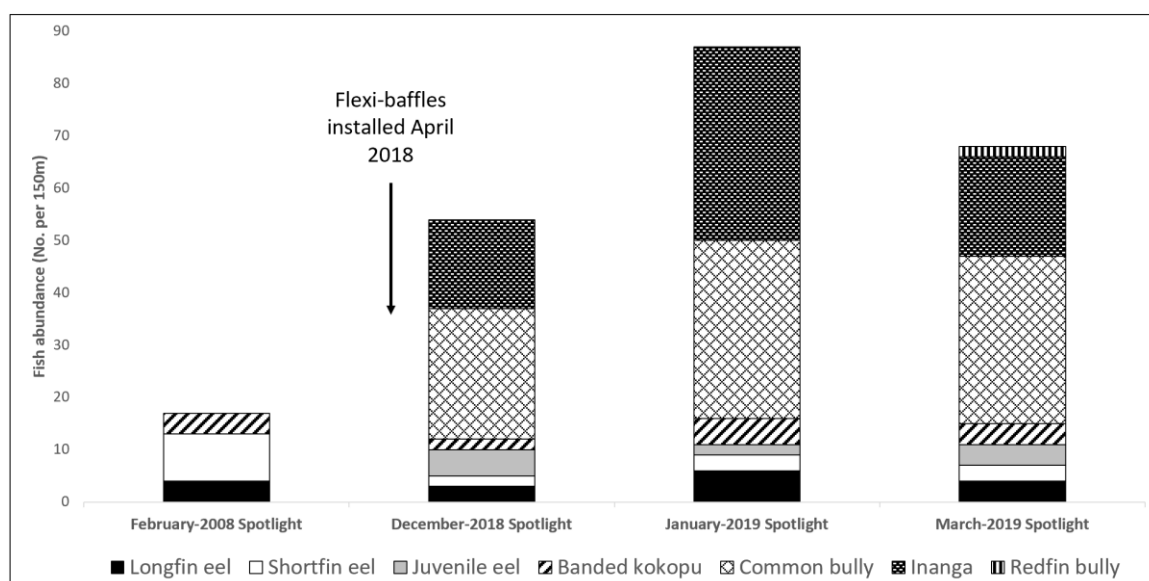
**Figure 4. Number of fish observed upstream of the culvert before (Feb 2008) and after (Dec 2018, Jan and Mar 2019) Flexi-baffles were installed.**

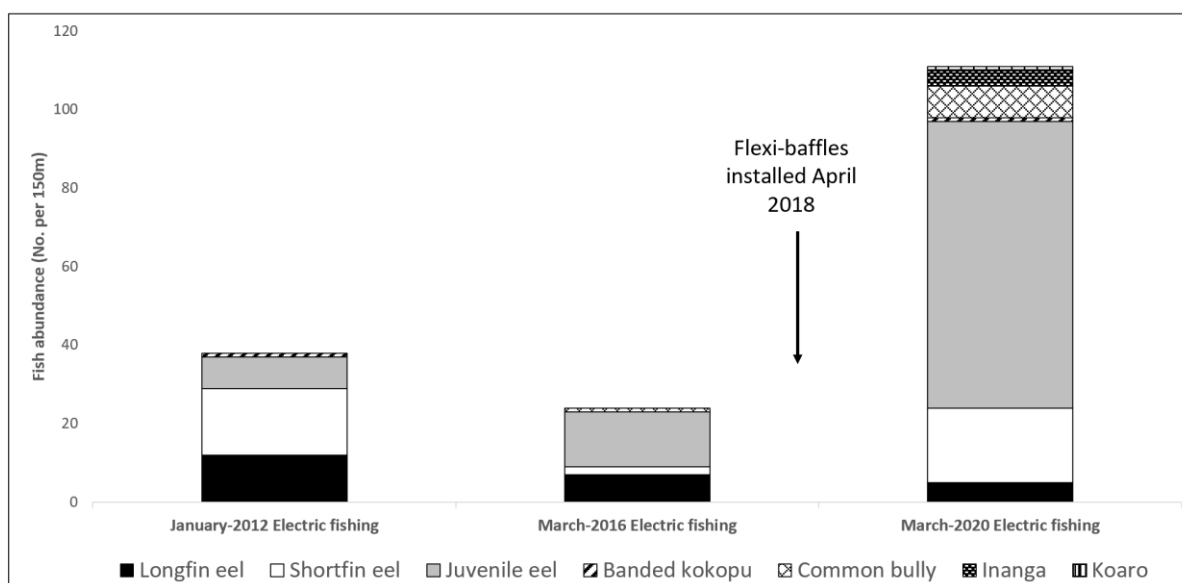
**Figure 5. Number of fish observed upstream of the culvert before (Jan 2012 and Mar 2016) and after (Mar 2020) Flexi-baffles were installed.**

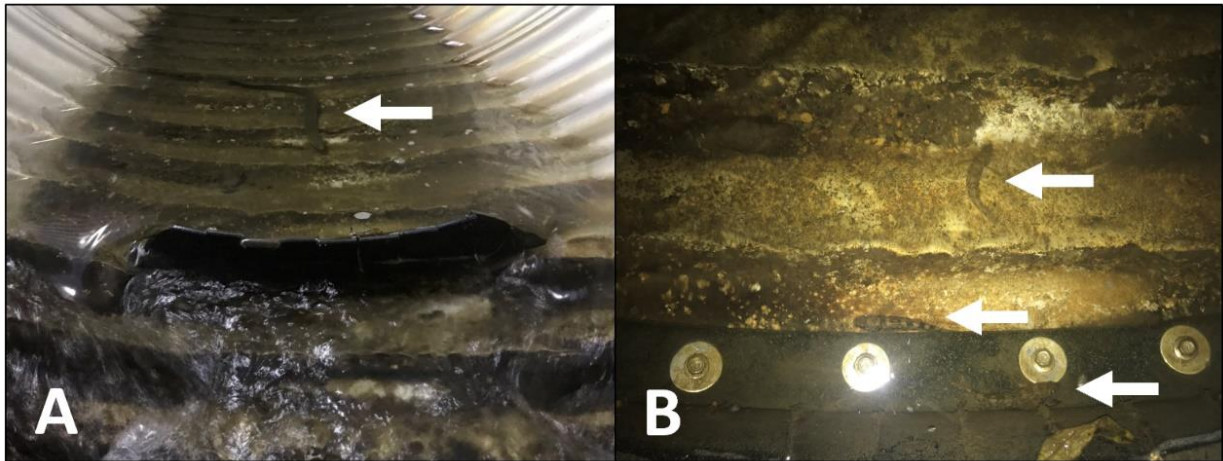
Several inspections within the culvert barrel have been carried out to assess baffle durability. During those inspections, anecdotal observations showed fish in pools between baffles and swimming upstream around the 45-degree cuts in the baffles and may be using baffles as refuge (Figure 6).

**Figure 6. Photo A shows an eel in a pool upstream of a Flexi-baffle. Photo B shows three common bully in a pool upstream of a baffle near the top of the culvert.**
